Reduction of tonal noise in lecture room air conditioning supply ducts

Jack B. Evans^a
JEAcoustics
Engineered Vibration Acoustic & Noise Solutions
1705 West Koenig Ln
Austin, Texas 78756-1206 USA

ABSTRACT

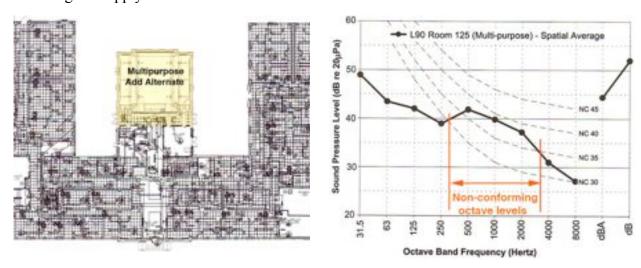
Project design criteria for a mixed-use space (lecture, assembly and reception) was NC 30-35, which is somewhat more relaxed than for a pure teaching space. At substantial completion of construction (just prior to initial occupancy), the owner's representative noted a tonal sound in the room. An octave spectrum analysis measurement of background sound requested for comparison with the allowable sound criteria showed broadband non-conformance in the midpart of the audible spectrum. Following a review by design engineers, it was noted that the AHU was rotated 90° from the position shown on engineering drawings and approved shop drawings, but the cause or reason was not known, but later was found to be due to space conflict with pump installations. The report indicated that the AHU rotation resulted in additional duct fittings, including the supply duct offset discussed above.

Figure 1: Multipurpose Room Addition to Academic Building (left) with Background Noise vs. Criteria (right)

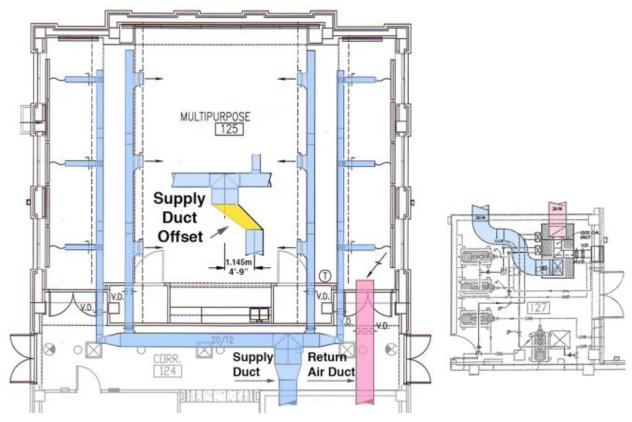
The multipurpose lecture room was designed as a "stand-alone" facility that could be constructed as an "add alternate" concurrently with the building or as a future expansion. A dedicated heating and cooling air handling unit (AHU) in it's own mechanical equipment room (MER) was planned immediately across a corridor/pre-function space from the multipurpose room. The heating, ventilating and air conditioning (HVAC) ducts included a primary or trunk supply duct with a "tee" fitting to create two branch ducts that would serve both sides of the room. There was a return air duct from the rear of the multipurpose room back to the MER. Space conflicts during construction caused the constructor to make a minor field modification to offset the supply duct just before the tee fitting, as shown on Fig. 2 below.

Figure 2: HVAC duct plan of the Multipurpose Room with inset of supply duct installed configuration (left) and plan of AHU MER as designed (right).

change tonality, indicating that the source must be upstream in the ducts or air handler. Very little was visible above the hard, solid corridor ceiling, but the supply duct offset was observed. The geometry of the duct installation, which had been altered to accommodate physical obstructions in the crowded ceiling plenum, caused the air to flow in a diagonal direction as it approached a 90° tee fitting. The multiple direction changes and internal duct fittings appeared capable of producing several small areas of turbulence.

- 1. Eliminate the offset duct and the diagonal approach to the tee fitting for the purpose of reducing the tee-fitting vane's vortex shedding turbulence. Three variations were proposed:
- Fabricate an acoustically lined expansion-chamber plenum to replace the offset duct and tee.
- Fabricate an expansion-chamber plenum to replace offset duct only with the tee fitting at exit.
- Replace the offset duct with two 90° elbows to accommodate the duct misalignment.

Subsequent to discussions about cost and feasibility for the various alternatives and affects on operations in the occupied space, the mechanical engineer and architect elected to pursue the acoustically lined expansion chamber plenum replacement of the offset duct and tee fitting. Difficulty of working in the crowded ceiling plenum above the corridor and pressure drop considerations for various configurations and fittings favored the more simple solution.

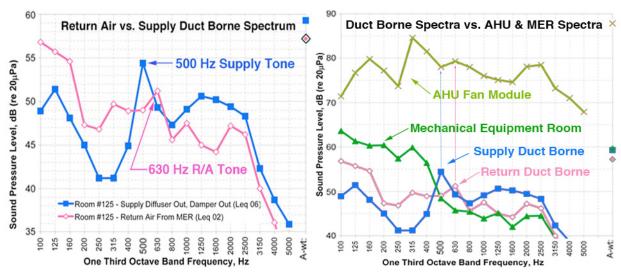
- 1. A tone² in the supply air (at diffuser nearest tee fitting) in the 500 Hz 1/3 octave, which exceeded the 400 Hz and 630 Hz sidebands by 9 and 6 dB, respectively, as shown in Fig. 3 (left). A similar tone was measured at the diffuser on the opposite side of the room (farther from tee fitting) with 7 dB and 6 dB sideband differentials (not illustrated below).

- 3. A tone was measured in return air (at duct inlet) in the 630 Hz 1/3 octave, which exceeded the 500 Hz and 800 Hz sidebands by only 2 and 5 dB, respectively, re: Fig. 3, but there was no evidence of the 500 Hz tone found in the supply duct.

- 4. The noise spectrum in the MER showed no prominence in the 500 Hz or the 630 Hz 1/3 octaves. If anything in the MER contributed to the supply duct tone, it was neither audible nor measureable above the ambient MER level with the AHU on. Comparison of AHU fan noise spectrum versus the tonal spectra in supply and return ducts are shown in Fig. 3 (right).

- 6. A peak level in the 315 Hz 1/3 octave in the fan noise spectrum, thought to be the blade passage frequency, is also visible in the MER and return air duct spectra, but not in the supply duct spectrum. The 630 Hz tone in the R/A duct is possibly a harmonic of the 315 Hz fan tone.

Figure 3: Tonal supply and return duct noise spectra (left) and duct borne versus AHU & MER spectra (right).³

After consideration of other potential sound source locations and spectra, the 500 Hz tonal sound appears to be generated within the supply duct. There are no unusual duct characteristics or fittings that would normally generate narrow band noise, except for the approximately 45° duct offset before the tee fitting. The airflow from the offset duct would flow across the edge of the internal vane that splits the duct flows going into each elbow segment of the tee fitting as illustrated in Fig. 4. The diagonal flow relative to the vane appeared to shed vortex turbulence behind the vane, which could generate noise at frequencies proportional to the size of the vortex.^{4,5} Figure 4: Eddy pattern at vane.
