# Cleveland, Ohio NOISE-CON 2003

## Case Study: Four University Law Lecture Auditoria Renovated for Improved Acoustics

First Author: Sarah B. Knight, E.I.T., of JEAcoustics

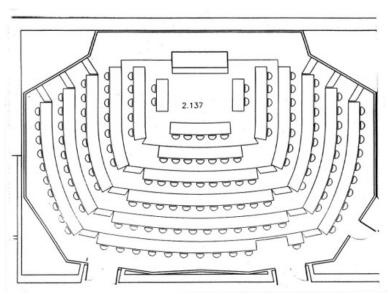
Figure 1: The Floor Plan of the Un-Renovated Space Showing the Furniture Plan

While there was adequate acoustically absorptive and diffusive surface finishes in the spaces, the acoustical treatments were not placed correctly in the room. They were not effective, and the space was reverberant. In addition to these problems, there was moderately excessive HVAC noise and intrusive corridor noise. The poor acoustics in the spaces were particularly problematic due to the style of teaching employed. See Figures 1, 2, and 3 below (Floor Plan, Reflected Ceiling Plan, and Section). See Figure 4, a photograph of the un-renovated space.

- ♦ It was recommended that the rear walls and immediately adjacent diagonal corner walls of the lecture auditoria be acoustically absorptive (NRC greater than or equal to 0.75). The existing splays on the rear walls could remain. See Figures 1 and 4. The absorption should be installed on the walls from 30" AFF or 36" AFF (above wainscoting) up to ceiling level, if the perimeter ceiling is reflective. If the perimeter ceiling is absorptive, the rear wall absorption should be from 30" AFF or 36" AFF to door head height. It was recommended that a minimum of 85% of the indicated surface area should be covered.

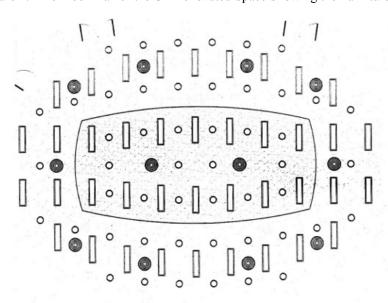
Figure 2: The Reflected Ceiling Plan of the Un-Renovated Space Showing the Furniture Plan

- ♦ JEA recommended sloping the front, side and rear perimeter of the ceiling to assist in orientation of sound paths. See the attached Section and Reflected Ceiling Plan. The center ceiling area should be sloped a minimum of three degrees upwards toward the back of the room to prevent standing wave propagation between the ceiling and floor (and table tops), and to direct sound towards the back of the auditorium. As an alternate to the nominal 3-degree slope towards the rear of the room, the center ceiling area could be sloped up towards the sidewalls to encourage reflection to the sides of the room. Alternately, in lieu of a sloped center ceiling area, a three dimensional, diffuse ceiling could be installed. There are lay-in, diffusive products available from several manufacturers.

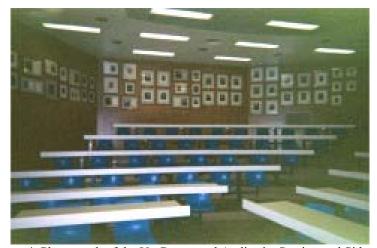
Figure 4: Photograph of the Un-Renovated Auditoria, Seating and Sidewall

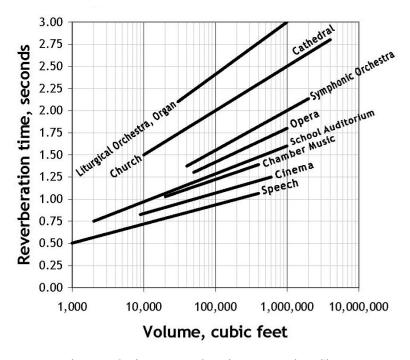
Figure 5: Optimum Reverberation Decay Time Chart

- Reverberation Decay Time: The reverberation decay time, T<sub>60</sub>, should be approximately 1.0 second in the 500-2000 Hertz octave bands (the speech frequencies). See Figure 5.

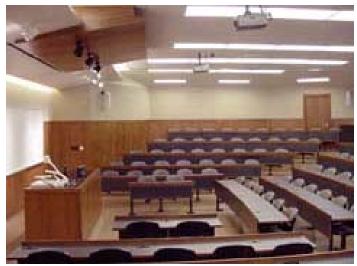
Figure 6: Side view Photograph of Renovated Auditoria

♦ Surface finish recommendations were for the most part implemented. The diffusive ceiling elements were added. However, the ceiling was not sloped as recommended. Acoustical absorption was added on the rear walls, above the wainscoting, to the ceiling height. The sidewalls were skewed and acoustical absorption was added to them as well, above the wainscoting. See Figures 6, 7, and 8 below, photographs of the renovated space.

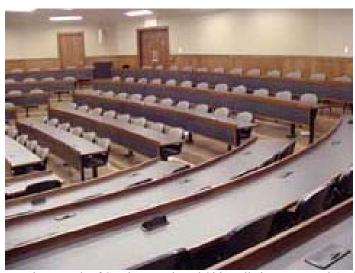
Figure 7: Photograph of Seating, Back and Sidewalls in Renovated Auditoria

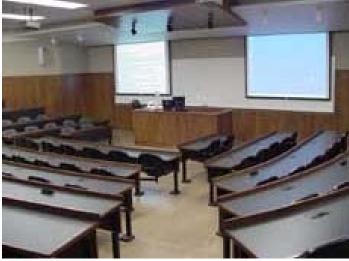
Figure 8: Photograph down the Aisle towards Speakers Podium in Renovated Auditoria

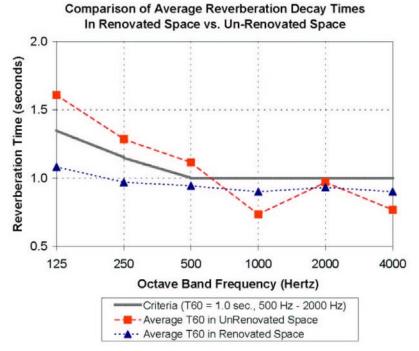
Figure 9: Comparison of Average Background Sound Levels in Renovated Space vs, Un-Renovated Space and Design Criteria

- The users of the space expressed approval of the new space. The students were able to hear the professors and each other better in the new space.
- ♦ The T<sub>60</sub> was reduced to 0.90 seconds in the speech frequencies and the reverberation decay time chart indicates a smooth (desirable) frequency response in the space. See Figure 9, below.
- The door seals had not yet been installed at the time that the validation measurements were made, and sound isolation measurements were not performed.
- The measurements indicate that the background sound level in the renovated space were actually higher than the background sound level in the un-renovated space. This is due to the elimination

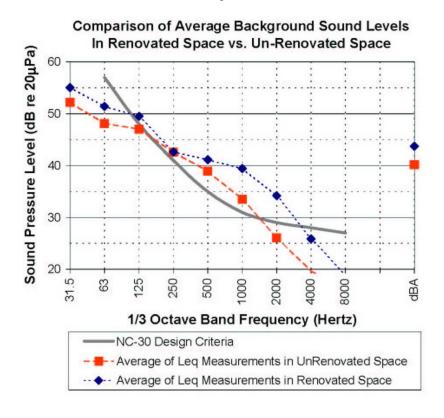
Figure 10: Comparison of Average Background Sound Levels in Renovated Space vs. Un-Renovated Space and Design Criteria
