Cleveland, Ohio
NOISE-CON 2003
2003 June 23-25

Case Study: Four University Law Lecture Auditoria Renovated for Improved Acoustics

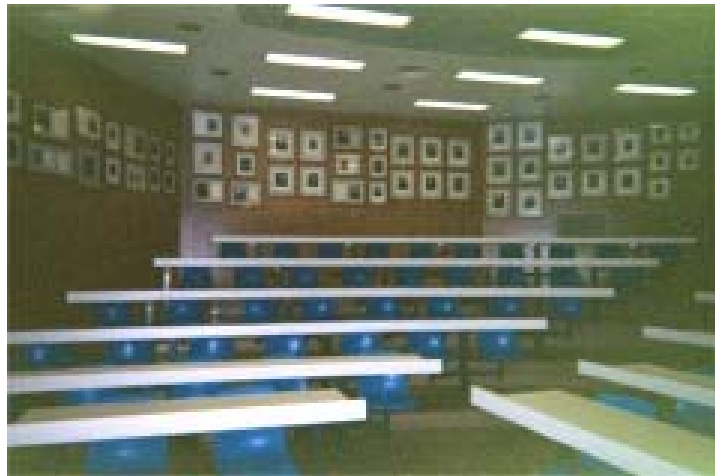
Figure 4: Photograph of the Un-Renovated Auditoria, Seating and Sidewall

While there was adequate acoustically absorptive and diffusive surface finishes in the spaces, the acoustical treatments were not placed correctly in the room. They were not effective, and the space was reverberant. In addition to these problems, there was moderately excessive HVAC noise and intrusive corridor noise. The poor acoustics in the spaces were particularly problematic due to the style of teaching employed. See Figures 1, 2, and 3 below (Floor Plan, Reflected Ceiling Plan, and Section). See Figure 4, a photograph of the un-renovated space.

- ◆ The front wall, behind the speaker was hard and reflective.
- ◆ The floors were hard, reflective terrazzo.
- ◆ The rear and side walls were a combination of absorptive and diffusive. Wall absorption and reflections were compromised by a large number of framed photographs hung on the walls.

- ◆ It was recommended that the rear walls and immediately adjacent diagonal corner walls of the lecture auditoria be acoustically absorptive (NRC greater than or equal to 0.75). The existing splays on the rear walls could remain. See Figures 1 and 4. The absorption should be installed on the walls from 30” AFF or 36” AFF (above wainscoting) up to ceiling level, if the perimeter ceiling is reflective. If the perimeter ceiling is absorptive, the rear wall absorption should be from 30” AFF or 36” AFF to door head height. It was recommended that a minimum of 85% of the indicated surface area should be covered.

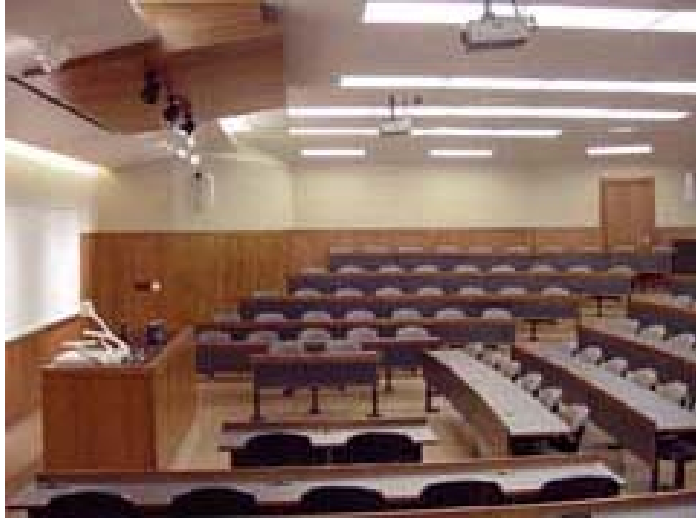
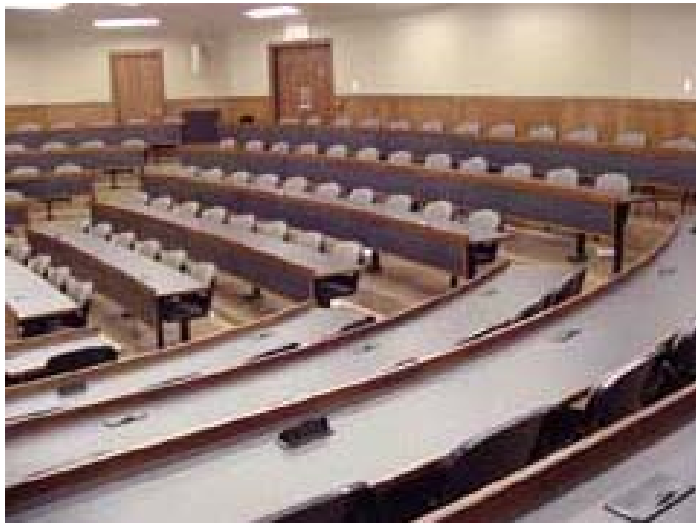
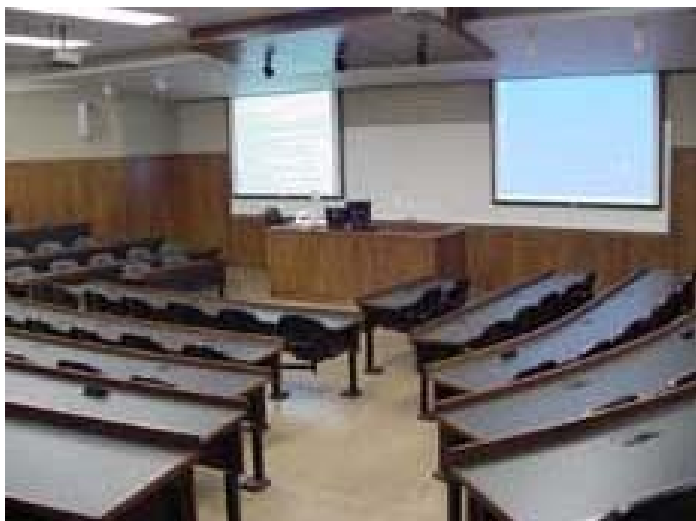
Figure 6: Side view Photograph of Renovated Auditoria

Figure 7: Photograph of Seating, Back and Sidewalls in Renovated Auditoria

Figure 8: Photograph down the Aisle towards Speakers Podium in Renovated Auditoria

- ◆ Surface finish recommendations were for the most part implemented. The diffusive ceiling elements were added. However, the ceiling was not sloped as recommended. Acoustical absorption was added on the rear walls, above the wainscoting, to the ceiling height. The sidewalls were skewed and acoustical absorption was added to them as well, above the wainscoting. See Figures 6, 7, and 8 below, photographs of the renovated space.

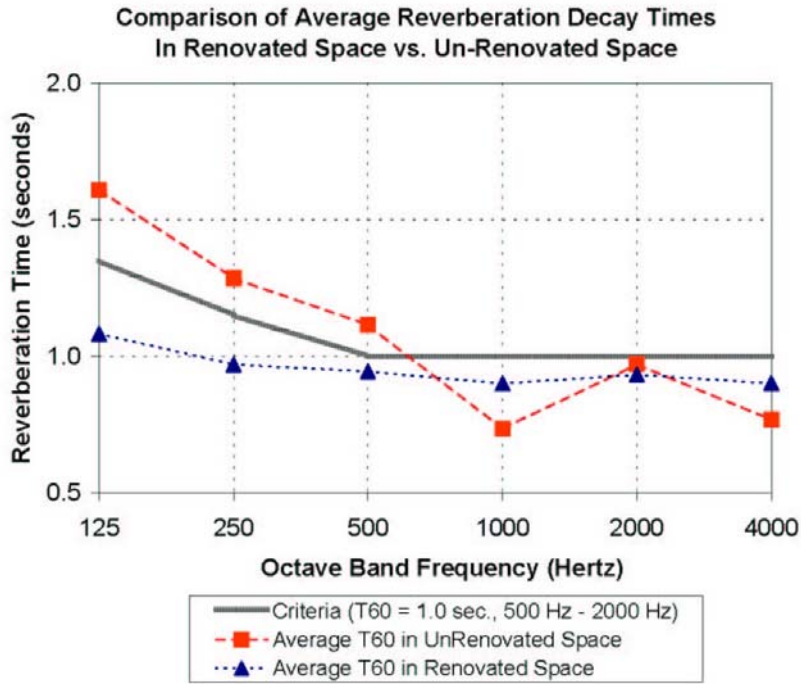
Figure 9: Comparison of Average Background Sound Levels in Renovated Space vs, Un-Renovated Space and Design Criteria

- ◆ The users of the space expressed approval of the new space. The students were able to hear the professors and each other better in the new space.
- ◆ The T₆₀ was reduced to 0.90 seconds in the speech frequencies and the reverberation decay time chart indicates a smooth (desirable) frequency response in the space. See Figure 9, below.
- ◆ The door seals had not yet been installed at the time that the validation measurements were made, and sound isolation measurements were not performed.
- ◆ The measurements indicate that the background sound level in the renovated space were actually higher than the background sound level in the un-renovated space. This is due to the elimination

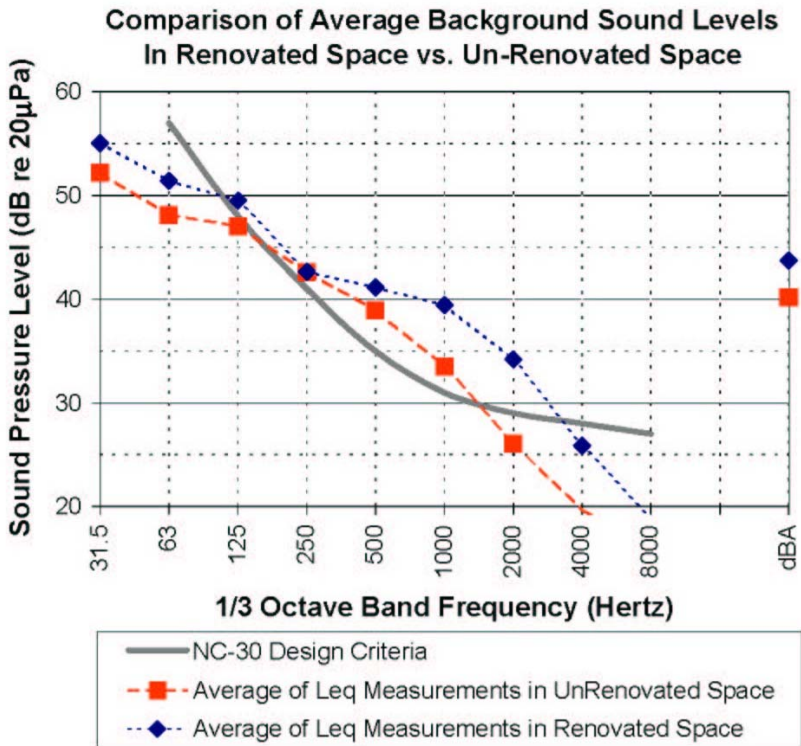
Figure 10: Comparison of Average Background Sound Levels in Renovated Space vs. Un-Renovated Space and Design Criteria
